Re: December 2017 Monthly Progress Report
Administrative Settlement Agreement and Order on Consent for Removal Action
USEPA Region 10 Docket No. CERCLA 10-2009-0255
Gasco Sediments Site within the Portland Harbor Superfund Site

Attachment A Monthly Visual Monitoring Report for Pilot Cap Vicinity

Project: NW Natural – Gasco

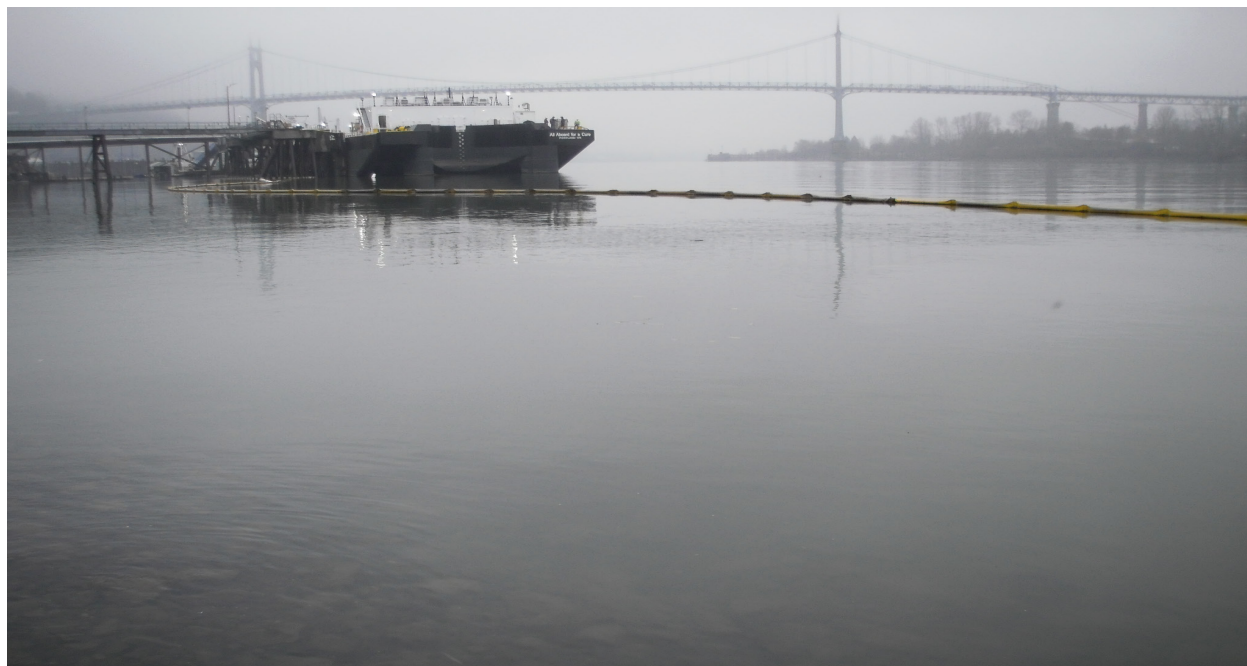
Photo 1

During the observation, a barge was docked but the FAMM containment boom was still placed across the cap area from the ship dock to the upriver dolphin. Two buoys that identify the cap area to mariners are in place as installed. The positions of the FAMM oil boom and warning buoys are shown in Photo 1.

FAMM Oil Boom Placement and Mariner Warning Buoys at Pilot Cap Area (12/27/2017)

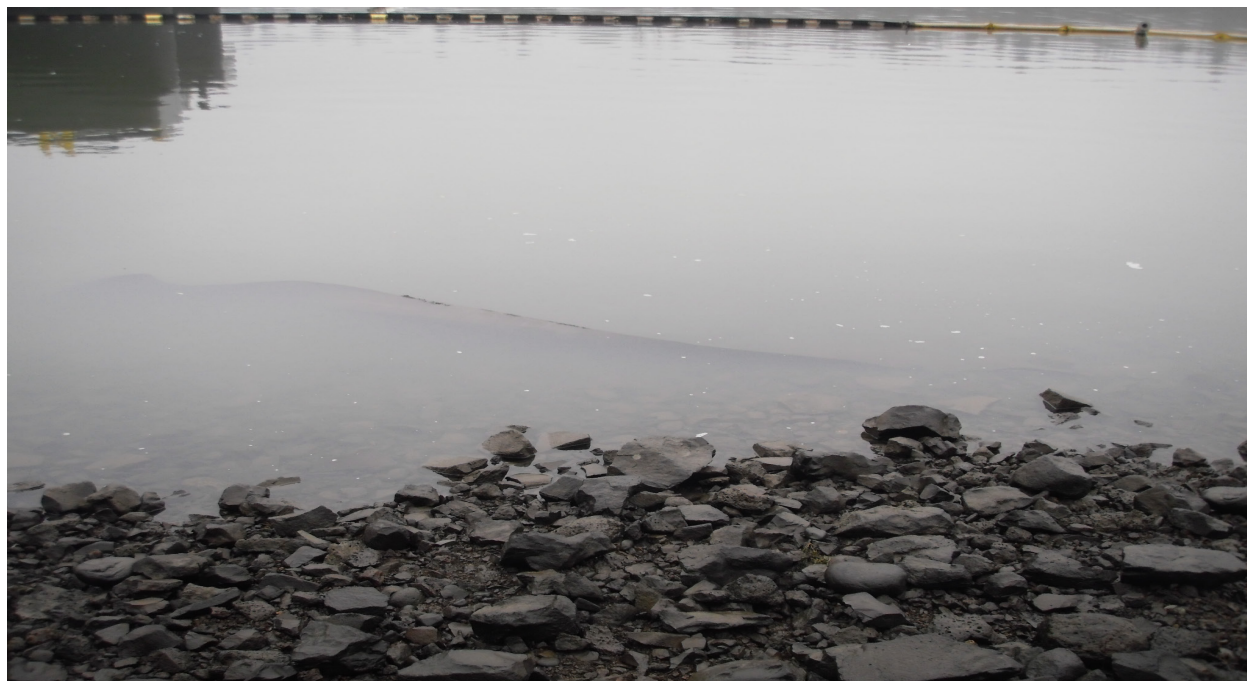
Photo 2

All previously noted organo-clay mat material segments are visible but underwater. A segment 5 feet in length is along the shoreline, near the lateral mid-point of the cap area. A 10-foot section is exposed near the water's edge, perpendicular to the shoreline at the upriver boundary of the cap area. A section of organo-clay mat material measuring 40 feet in length is exposed near the downriver extent of the cap at the water's edge with the exposed edge floating in the water (Photo 2).

Mat Material Visible at the Lateral Mid-Point of the Cap Area (12/27/2017)

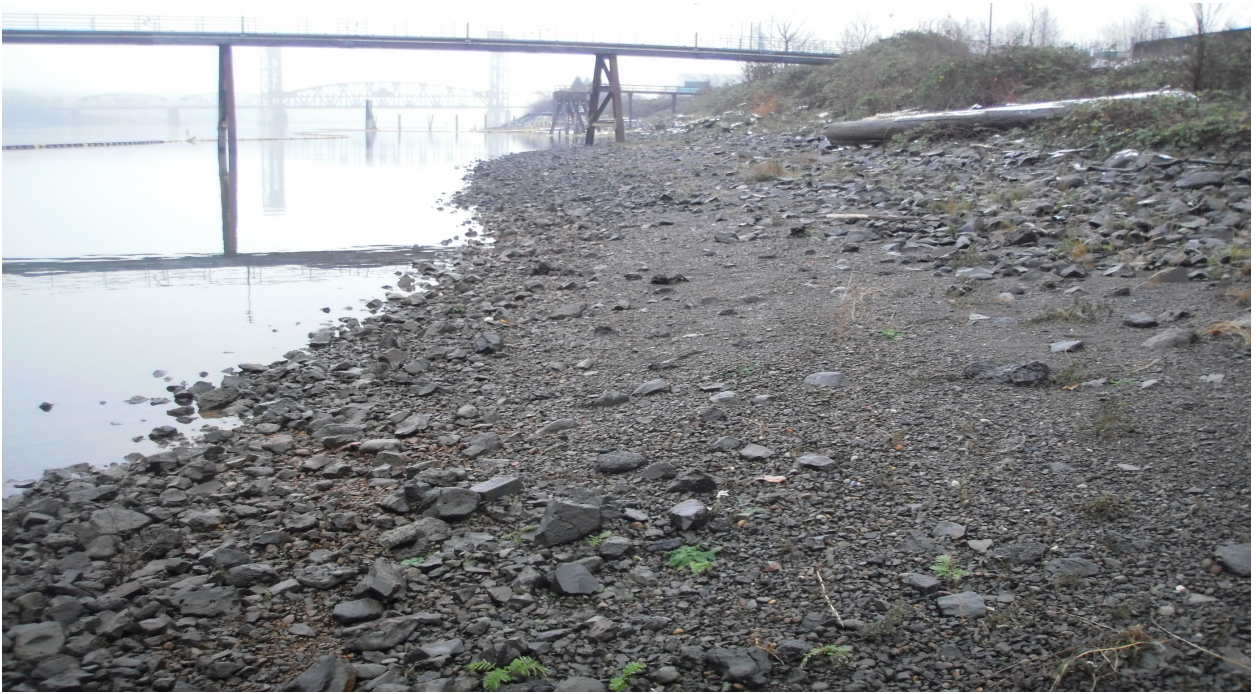
No sheen is evident in or around the cap area. Photo 3 shows the water surface and shoreline immediately downriver of the sediment cap.

Photo 3
Conditions Immediately Downriver of Cap Area (12/27/17)
